Environmental Pollution by Hexavalent Chromium, etc. Caused by Nickel Mining and Smelting Operations in Rio Tuba, Palawan Island

Junichi Onuma
(Nagoya University Disaster Research Group)
(December 4, 2024)

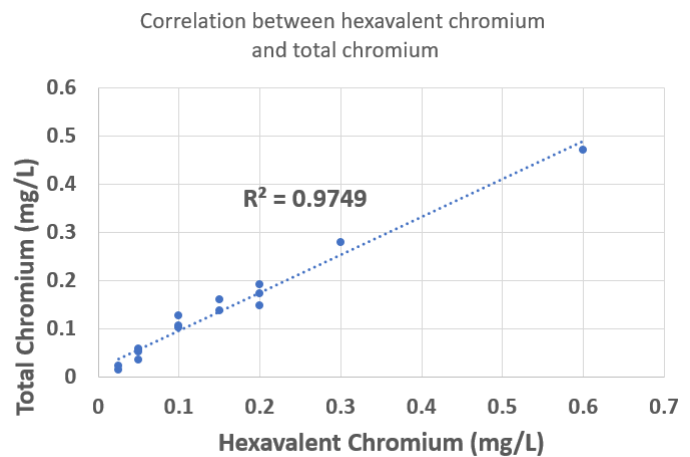
Figure 3: Correlation between hexavalent chromium by simple pack test and total chromium by ICP/MS

In a preliminary survey conducted in 2009, we brought several types of simple pack tests to the field and attempted to measure at a survey point (a crossing point of a public road) set in the midstream of the Togpon River; as a result, we found that hexavalent chromium exceeded the then Japanese Environmental Standard and the then Japanese Water Supply Act standard (0.05 mg/L). When the sample was brought back to Japan and re-measured, it still exceeded the standards. When this sample was analyzed by ICP/MS, total chromium was detected at a concentration almost equivalent to the hexavalent chromium. Among the simple pack tests, the test kit for hexavalent chromium is relatively accurate, since it uses almost the same principle as the analysis method of the Industrial Standardization Act (JIS Act) 4), with the only exception that the accuracy is slightly reduced in the comparison with the concentration class color printed chart when determining the concentration. The linear relationship between hexavalent chromium and total chromium for the samples collected in the midstream of the Togpon River is shown in Figure 3.

In environmental water quality surveys in Japan, rapid measurement is necessary because highly reactive hexavalent chromium is easily reduced to trivalent chromium by reacting with organic matter in the water. However, it was found that the reduction reaction is unlikely to occur in tropical regions where organic matter is less abundant.

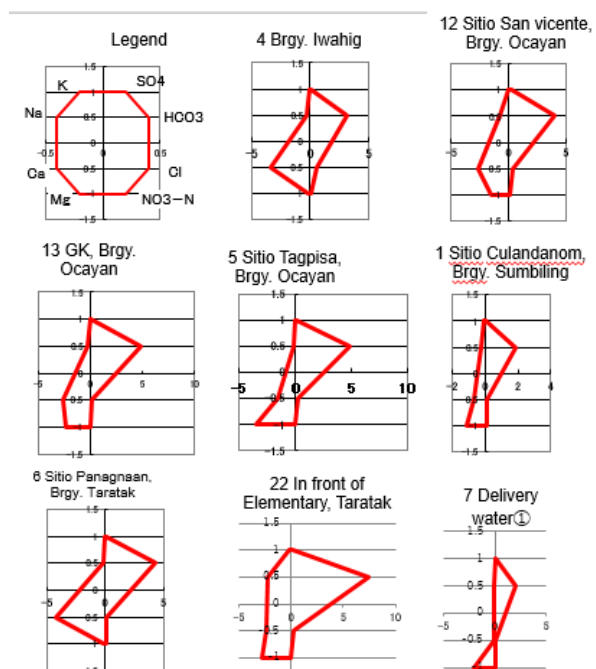
Figure 4: Comparison of groundwater by hexadiagrams

To compare the ionic balance of the groundwater, hexadiagrams are shown in Figure 4. Location numbers 4 and 6 are Ca-HCO₃ type, location numbers 12 and 13 are CaMg-HCO₃ type, location numbers 1 and 5 are MgCa-HCO₃ type, location number 22 is MgNaCa-HCO₃ type, and location numbers 7 and 8 are Mg-HCO₃ type. The delivery water discussed below has a completely different ionic composition from the others, and is probably not groundwater but surface water from some river. It has a peculiar composition with low sodium and high magnesium. The sample 22 differs from the others by having a relatively high sodium concentration. It is also distinctive for its relatively high concentration of barium. The sample 12, 13, 1, and 5 may be groundwater accumulated in limestone layers of coral reef origin, while samples 4 and 6 are low in magnesium and high only in calcium cations, but may also be accumulated water in the limestone layers. Except for the sample 1 in Sumbiling village, no groundwater contamination by nickel or hexavalent chromium of nickel laterite origin was identified.

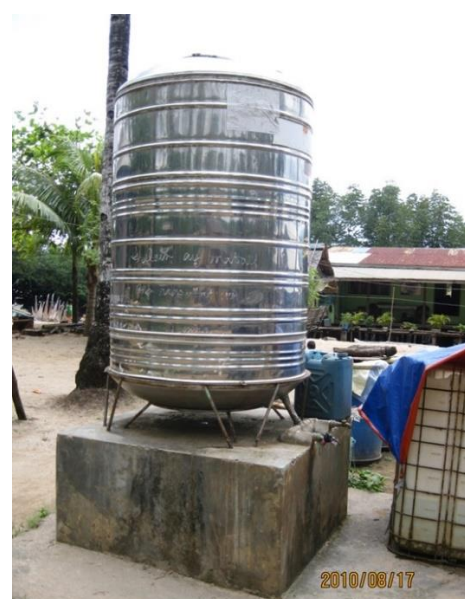
Figure 5: Delivery water tank

We also analyzed delivery water as drinking water at two locations where CBNC had installed stainless steel tanks in indigenous villages (Figure 5) and supplied the water by tank trucks on a regular basis. This was because hexavalent chromium had been detected in the delivery water collected during a preliminary survey in 2009, and the company had been notified about it. Fortunately, no hexavalent chromium was detected in this survey. CBNC reported to us that it had changed the source of the water supply after discovering that the tank truck driver had collected and supplied contaminated river water. This is an incident that should not be tolerated at all, even if it was a free service project to the indigenous community. In addition, without our survey, there is a possibility that the incident would have remained undetected and could have led to health problems.

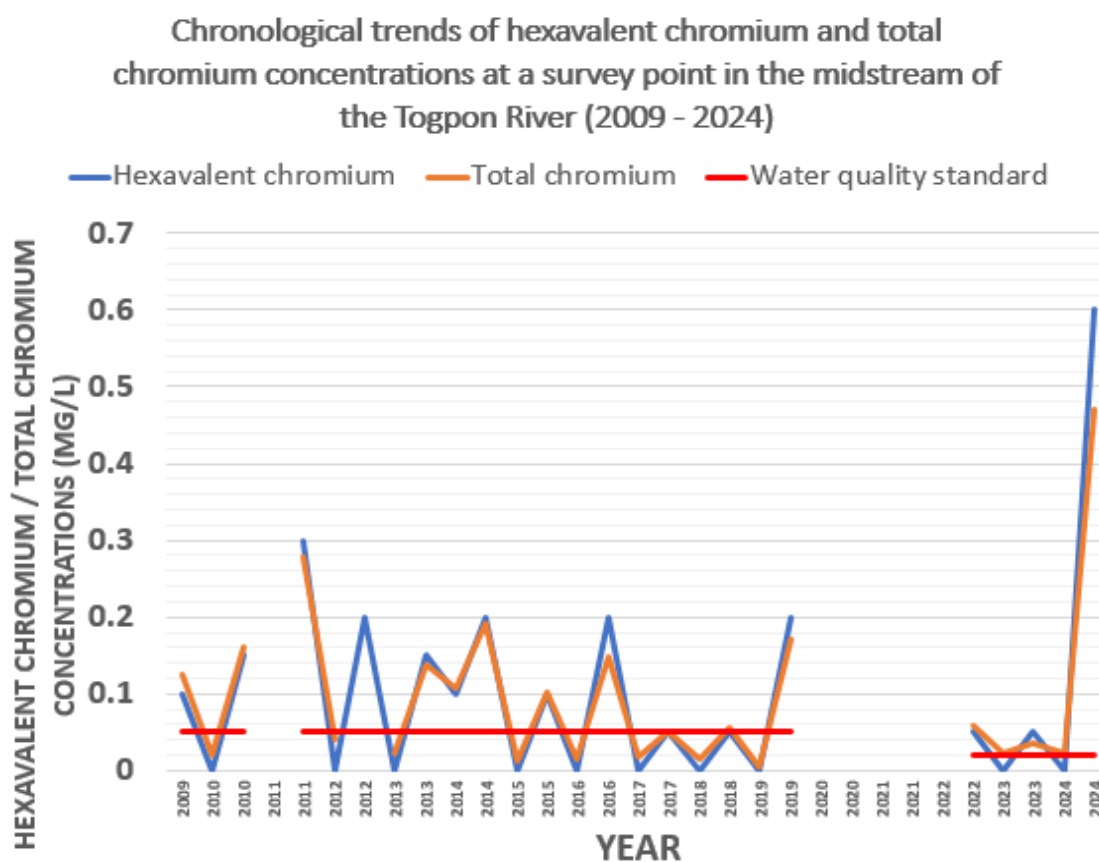
Figure 6: Chronological trends of hexavalent chromium and total chromium

Figure 6 and Figure 7 show the results of the continuous monitoring surveys at a survey point in the midstream of the Togpon River. Surveys were conducted in March or April during the dry season and between August and October during the rainy season; the interruption from 2020 to 2022 was due to the COVID-19 disaster. It is again shown that hexavalent chromium and total chromium are well matched. It is also clear that hexavalent chromium and total chromium are lower during the dry season and higher during the rainy season. Significant exceedances of the Japanese Environmental standard and the Japanese Water Supply Act standard (both 0.05 mg/L, and 0.02 mg/L after the revision) are evident during the rainy season. In 2024, a highest concentration of 0.6 mg/L of hexavalent chromium and 0.471 mg/L of total chromium was observed during the rainy season, equivalent with 24 to 30 times higher than the standards and the highest concentration in 15 years, respectively. The slightly lower values in 2017 and 2018 as well as in 2022 and 2023 were likely due to less rainfall in the rainy seasons than in normal years. Furthermore, it should be noted that the Philippine Department of Environment and Natural Resources (DENR) Administrative Order No. 2016-08, “Water Quality Guidelines and Effluent Standards,” (2016. 5-year grace period) stipulates the standard for hexavalent chromium as 0.01 mg/L for freshwater (the effluent standard is 0.02 mg/L) and as 0.05 mg/L for marine water (the effluent standard is 0.1 mg/L), while the Philippine Department of Health (DOH) “National Drinking Water Standards” (2017) stipulates the standard for total chromium as 0.05 mg/L.

It is deeply concerning that the situation of contamination has not shown any sign of improvement in the 15 years since this survey was begun. We strongly urge SMM to take responsible measures to prevent pollution.

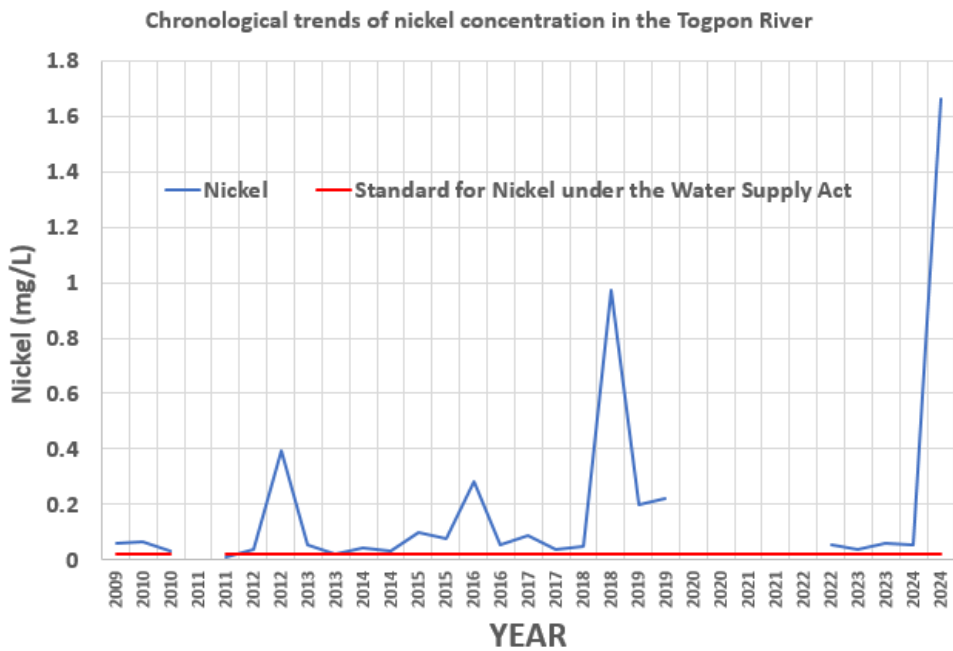
Figure 7: Chronological trends of nickel concentration at a survey point in the midstream

For nickel, the correlation with the dry and rainy seasons is not clear, which may suggest that the mechanism is different from the elution of hexavalent chromium. Unlike hexavalent chromium, the water quality always exceeds the standard significantly compared to the 0.02 mg/L as evaluation value under the Japanese Water Supply Act, regardless of the dry or rainy season. In particular, the 1.66 mg/L in the rainy season of 2024 is approximately 80 times higher than the standard value. Although there is no Japanese Environmental standard for water quality, it is listed as an item requiring monitoring for the protection of human health.

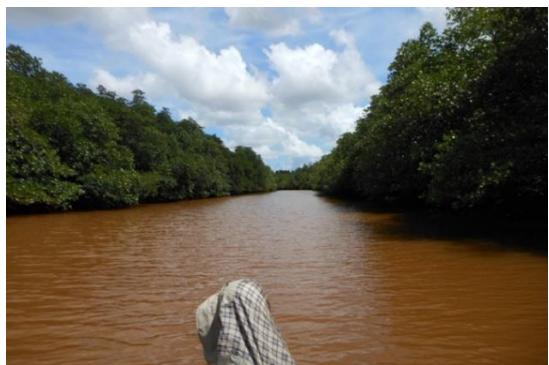
Figure 8: Tidal area of the Togpon River

During the survey of the tidal area of the Togpon River, it was observed that a mound had formed near the confluence of the Togpon River with the Rio Tuba estuary, which was big enough to get a hold of the bottom of the chartered fishing boat. In addition to the large inflow of sediment from the Rio Tuba mine via the Togpon River, the dissolved metal ions were estimated to have mixed with seawater (pH 8.2~8.4), which is slightly alkaline, resulting in hydroxide precipitation. The reddish-brown turbidity of tidal river water during the rainy season (Figure 8) supports this presumption. The main components of the reddish-brown precipitation are iron and manganese, which are the main components of laterite soils, and it is

assumed that toxic heavy metals are also precipitated by the same mechanism.

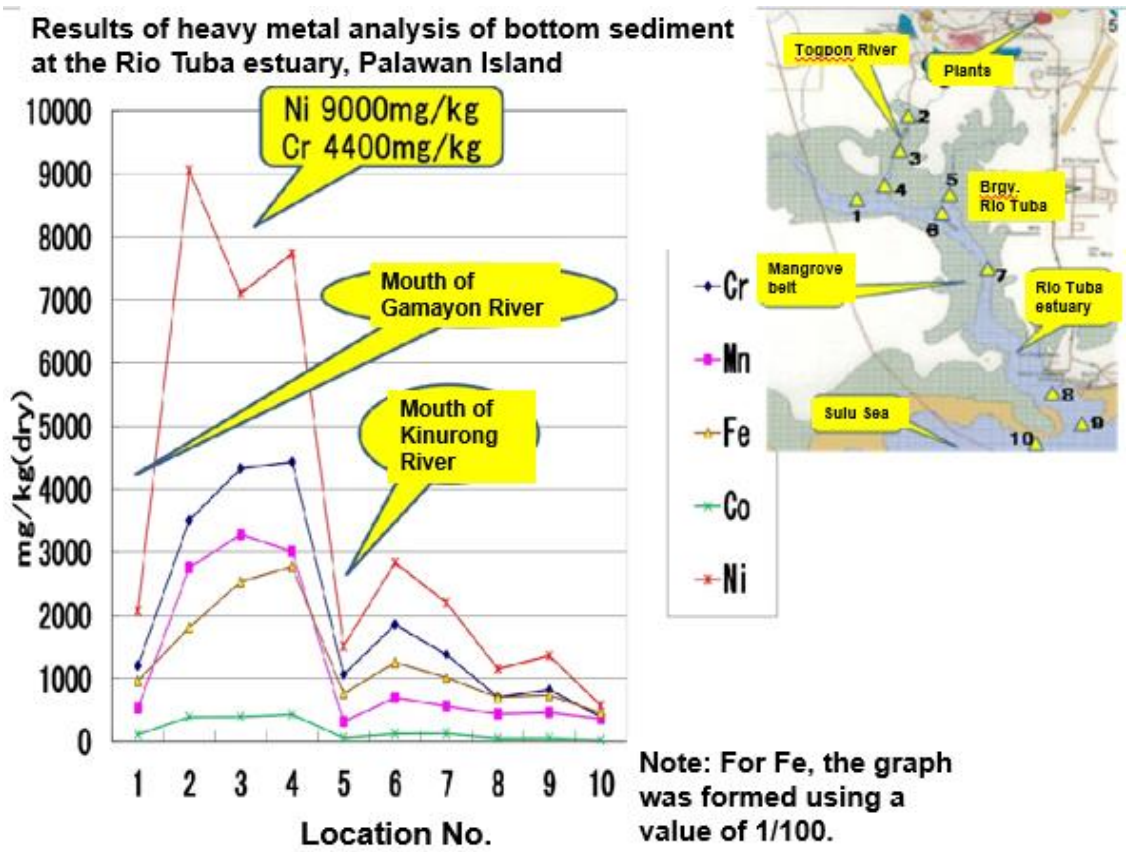
Figure 9: Results of heavy metal analysis of bottom sediment at the Rio Tuba estuary, Palawan Island

To reveal these facts, in 2011, we collected bottom sediments in the Rio Tuba estuary using an Ekman-Birge Bottom Sediment Sampler, and the results of heavy metal analysis are shown in Figure 9. Compared to location No. 1, which is under the influence of the Sumbiling and Gamayon Rivers while still being influenced by the Togpon River but not polluted, the upper end (No. 2), middle (No. 3), and river mouth (No. 4) of the Togpon River tidal area showed higher accumulation of nickel (7,000 to 9,000 mg/kg (per dry weight)), chromium (3,600 to 4400 mg/kg), Manganese (about 3,000 mg/kg), and iron (170,000-280,000 mg/kg). The concentration of heavy metals gradually decreases from location No. 6 to location No. 9 at the mouth of Rio Tuba estuary, but has not reached zero. The influence of reddish-brown sludge can be seen even from the external appearance at the open sea (location No. 10). This result indicates that the bottom sediments throughout the Rio Tuba estuary are strongly contaminated by heavy metals sourced from the Togpon River. Although the mangrove forests have not yet reached the point of dying out, the destruction of the ecosystem must be considered to be continuing, given that fisherfolks have reported that they could no longer catch fish, and it is expected that their path to restoration will be quite difficult.
